**Flood Control Project Maintenance  
Levee Inspections**

**Fall 2019 Levee Maintenance Deficiency Summary Report**

**San Joaquin River Basin**

## Reclamation District No. 2064 River Junction

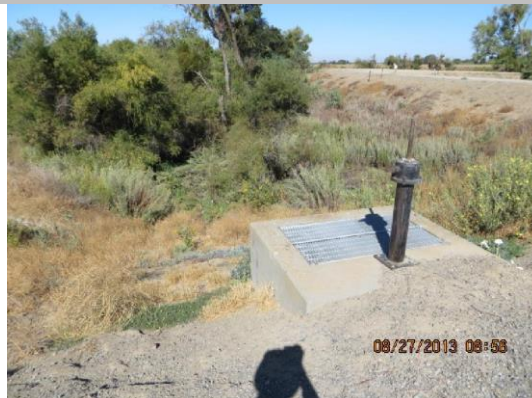
Photo 1 of 3 : UCIP\_FA\_2019\_43603\_31258.jpg

LM Start	0.06	Rating **	A/W	Issue No.	45
LM End	0.06	Issue Type +	Ma	Location *	
Category	Supplemental			GPS Latitude/Longitude	
				Start	End
Item	DRAFT DWR UCIP LMA Responsibility			37.709804 °	37.709804 °
				-121.267559 °	-121.267559 °
DWR ID	20511				
Comment Code					
Inspector Comment					
DS_ID:20511 FS_ID:43603 EP_NO: N/A Repair Type: No Action Needed Crossing Status: Found UCIP Comments: Debris removed from flap gate on waterside tow FIELD_STRUCT_DESC: 36-inch by 36-inch reinforced concrete box drainage culvert through the levee, 21 feet below the crown. Concrete U-shaped headwalls on both ends. Slide gate in a 6-foot by 7-foot concrete riser on the waterside (WS) slope. Flap gate on the WS end. Flashboard slots on the landside (LS) headwall. [Additional Reference(s): DWR Levee Log, 2005. USACE San Joaquin O&M Manual 3, December 1968, (HLM 0.07)]. FS Date: 3/2/2015

Slide gate in concrete riser on WS shoulder.

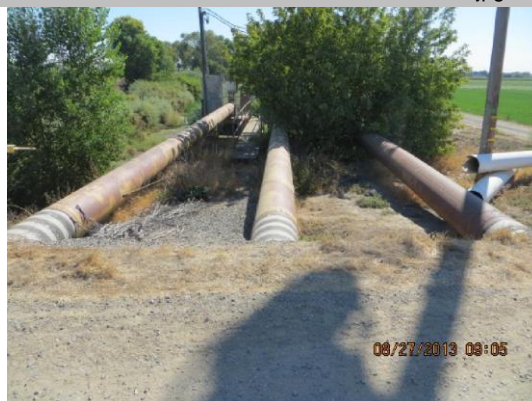
Photo 1 of 3 : UCIP\_FA\_2019\_22729\_38458.jpg

LM Start	0.06	Rating **	M	Issue No.	47
LM End	0.06	Issue Type +	En	Location *	
Category	Supplemental			GPS Latitude/Longitude	
				Start	End
Item	DRAFT DWR UCIP Field Study			37.709698 °	37.709698 °
				-121.267536 °	-121.267536 °
DWR ID	20527				
Comment Code					
Inspector Comment					
DS_ID:20527 FS_ID:22729 EP_NO: 13907 Repair Type: Non-Urgent Crossing Status: Found UCIP Comments: This pipe has less than 1-foot of cover. FIELD_STRUCT_DESC: 2 of 3: 24-inch coated steel drainage discharge pipe through the levee, 2 feet below the crown. Two 100-horsepower and one 75-horsepower pumps on pier at the landside (LS) toe. Siphon breaker on the waterside (WS) shoulder. (Permit No. 13907, 1985 - Reclamation District No. 2064). [Additional Reference(s): DWR Levee Log, 2005]. FS Date: 8/27/2013

Pipe visible on LS.

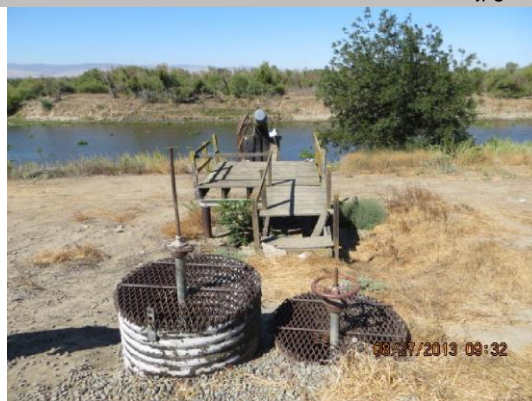
Photo 1 of 3 : UCIP\_FA\_2019\_40792\_31377.jpg

Comment Code						
Inspector Comment						
DS_ID:20533						
FS_ID:40792						
EP_NO: N/A						
Repair Type: Non-Urgent						
Crossing Status: Found						
UCIP Comments: Pump and slant pipe missing from structure on WS slope.						
FIELD_STRUCT_DESC: 12-inch concrete encased steel irrigation pipe through the levee, 13 feet below the crown. Slant pump on the waterside (WS) toe. Slide gate in a 36-inch corrugated metal pipe (CMP) riser on the WS shoulder. 6-foot by 6-foot concrete distribution box and filter plant on the landside (LS) toe. 2-inch galvanized iron electrical conduit at the same location. [Additional Reference(s): DWR Levee Log, 2005. USACE San Joaquin O&M Manual 3, December 1968, (HLM 1.24)].						
FS Date: 8/27/2013

Slide gate in CMP riser on WS shoulder.

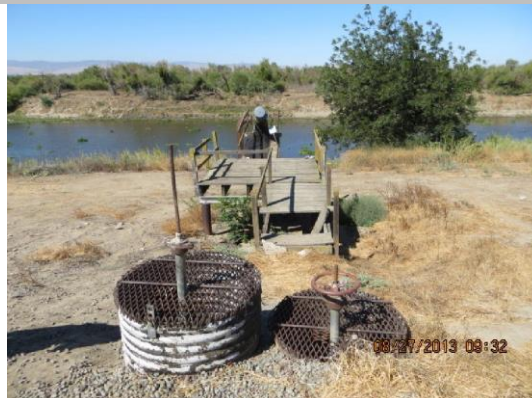
Photo 1 of 3 : UCIP\_FA\_2019\_53378\_38462.jpg

Comment Code						
Inspector Comment						
DS_ID:20524 FS_ID:53378 EP_NO: 3739 Repair Type: Urgent Crossing Status: Found UCIP Comments: 10/10/2018 There is a lot going on at this location; levee erosion and the same sink hole and pipe integrity issue on LS that looks like it has only gotten worse, installation of new steel pipe on WS, and the WS slope looks to have eroded some since the last inspection. Keeping as Urgent, and highly recommend full audit of this crossing, including permitted work and internal pipe inspection (D. Sanoski - DWR UCIP).11/16/2016 same as last inspection leak has created sink hole near concrete distribution box located on the LS. Hole in pipe is visible at sink hole. Need to contact owner to address leak on LS. Recommend an internal inspection be completed for the pipe through the levee to determine pipe integrity. (O. Magana - DWR UCIP)08/27/2013 Some leakage at connection between pipe and distro box on LS toe. This may indicate internal failure of pipe. (W. Wylie - DWR UCIP) FIELD_STRUCT_DESC: 16-inch coated steel irrigation pipe through the levee, 10.75 feet below the crown. 2-inch galvanized iron electrical conduit at the same location. Slant pump on the waterside (WS) toe. Slide gate in a 36-inch corrugated metal pipe (CMP) riser on the WS shoulder. 6-foot by 6-foot concrete distribution box and filter plant on the landside (LS) toe. (16-inch pipe authorized under Permit No. 3739, 1961 - Mortensen and Barker). FS Date: 10/10/2018 1:10:00 PM

Slant pump on WS toe. Slide gate in 36-inch CMP riser on WS shoulder.

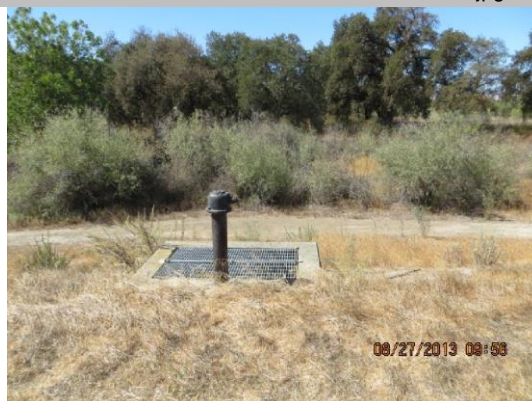
Photo 2 of 3 : UCIP\_FA\_2019\_18748\_31379.jpg

LM Start	1.65	Rating **	A/W	Issue No.	51 (cont)	
LM End	1.65	Issue Type +	Ma	Location *		
Category	Supplemental			GPS Latitude/Longitude		
				Start	End	
Item	DRAFT DWR UCIP LMA Responsibility			37.690072 °	37.690072 °	
				-121.269823 °	-121.269823 °	
DWR ID	20514					
Comment Code						
Inspector Comment						
DS_ID:20514 FS_ID:18748 EP_NO: N/A Repair Type: No Action Needed Crossing Status: Found UCIP Comments: FIELD_STRUCT_DESC: 30-inch by 30-inch reinforced concrete box drainage culvert through the levee, 15 feet below the crown. Slide gate in a concrete riser on the waterside (WS) shoulder. Concrete U-shaped headwalls on both ends. Flap gate on the WS end. [Additional Reference(s): DWR Levee Log, 2005. USACE San Joaquin O&M Manual 3, December 1968, (HLM 1.65)]. FS Date: 8/27/2013

Slide gate in concrete vault on WS shoulder.

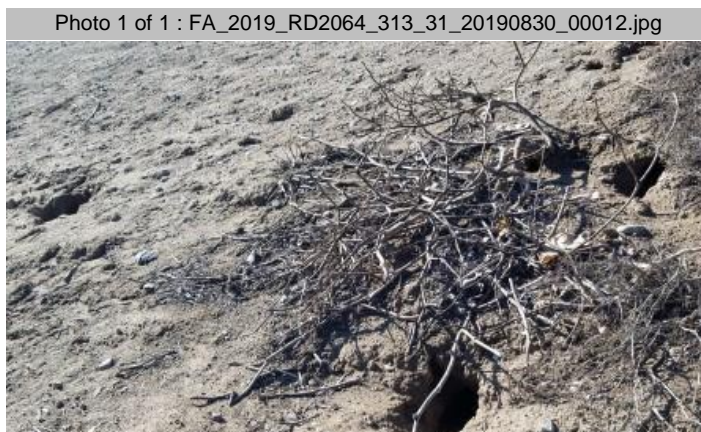
LM Start	<b>2.14</b>	Rating **	M	Issue No.	<b>31</b>
LM End	<b>2.14</b>	Issue Type +	Ma	Location *	LS
Category	Earthen Levee			GPS Latitude/Longitude	
				Start	End
Item	Animal Control			37.688714 °	37.688714 °
				-121.261480 °	-121.261480 °
DWR ID	DWR_RD2064_01_f_2018_31				
Comment Code					
A3 : No rodents visible, but rodent burrows visible; need to backfill and compact or grout burrows.					
Inspector Comment					
Old rodent holes need to be backfilled.

View of animal holes on levee slope. Fall 2018

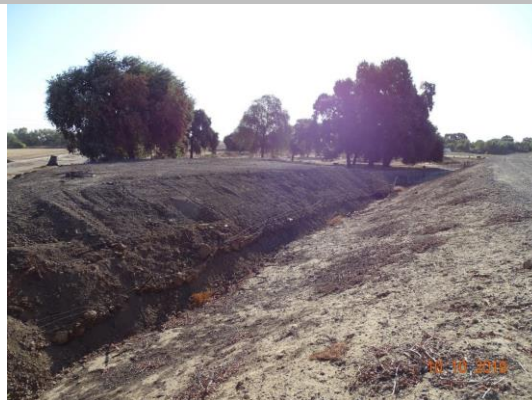
Photo 1 of 1 : FA\_2019\_RD2064\_313\_38\_20191111\_00055.jpg

LM Start	2.45	Rating **	U	Issue No.	38
LM End	2.47	Issue Type +	En	Location *	WS
Category	Earthen Levee			GPS Latitude/Longitude	
				Start	End
Item	Encroachments			37.687402°	37.687158°
				-121.256542°	-121.256317°
DWR ID	DWR_RD2064_01_f_2019_38				
Comment Code					
MA : Material					
Inspector Comment					
Land owner is relocating fence and moving earth material along the landside easement. RD has advised landowner of possible encroachment issues. The RD has already been in contact with the CVFPB. Fall 2019

View of fence being relocated along landside toe. Fall 2019

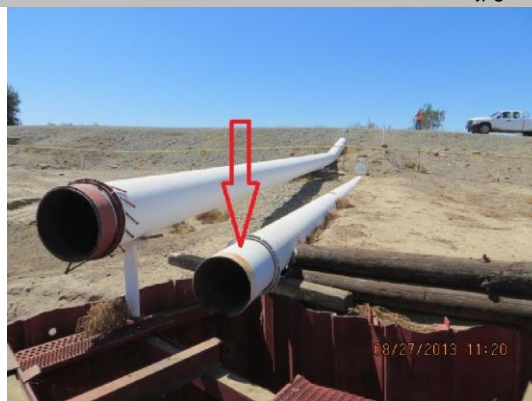
Photo 2 of 3 : UCIP\_FA\_2019\_19044\_31843.jpg

Pipe visible at sump off LS toe. No pump or appurtenances.

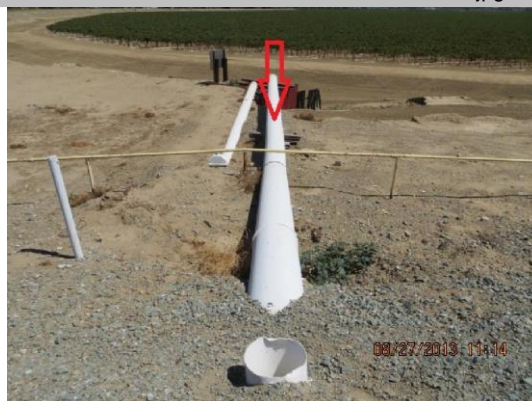
Photo 1 of 3 : UCIP\_FA\_2019\_22733\_38468.jpg

Pipe and vent visible on LS slope.

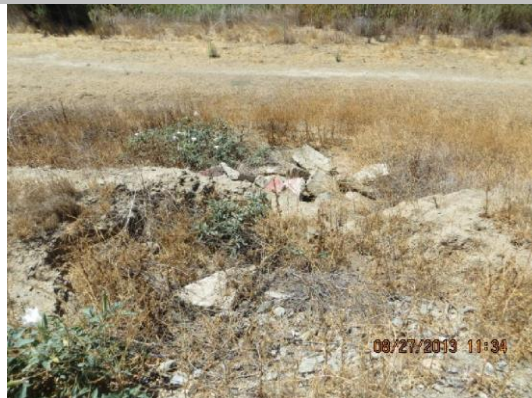
Photo 2 of 2 : UCIP\_FA\_2019\_19046\_31848.jpg

LM Start	<b>3.60</b>	Rating **	M	Issue No.	<b>59 (cont)</b>							
LM End	<b>3.60</b>	Issue Type +	En	Location *								
Category	Supplemental		GPS Latitude/Longitude									
			Start	End								
Item	DRAFT DWR UCIP Field Study		37.675005°	37.675005°								
			-121.263103°	-121.263103°								
DWR ID	20534											
Comment Code												
Inspector Comment												
DS_ID:20534 FS_ID:19046 EP_NO: 13609 Repair Type: Non-Urgent Crossing Status: Indicator Found UCIP Comments: Pipes should be abandoned properly. FIELD_STRUCT_DESC: *REMOVED* 2 of 2: 24-inch steel drainage pipe through the levee, 12.67 feet below the crown. Approximately 75 feet upstream of first 24-inch pipe. According to notes in permit, concrete rubble was placed over the pipe on the waterside (WS) slope. (Permit No. 13609, 1983 - Reclamation District No. 2064). FS Date: 8/27/2013

Concrete rubble on WS slope possible indicator of abandoned pipe location.

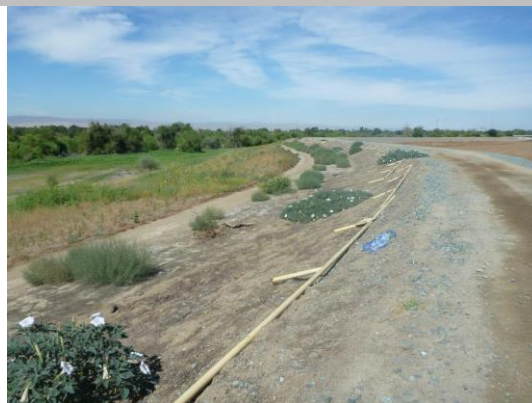
Photo 1 of 3 : FA\_2019\_RD2064\_313\_24\_20190830\_00006.jpg

LM Start	<b>3.92</b>	Rating **	A/W	Issue No.	<b>24</b>							
LM End	<b>4.03</b>	Issue Type +	Ob	Location *								
Category	Supplemental		GPS Latitude/Longitude									
			Start	End								
Item	2017 Storm Damage		37.673190°	37.672180°								
			-121.258140°	-121.256490°								
DWR ID	LMA-487											
Comment Code												
Inspector Comment												
Levee Evaluation Comments Description: The damaged area is due to extensive seepage occurring from high river flows, especially when the water level is above 25.0' at the Vernalis Gauge. The damage is from long-term saturated soil within the levee structure beyond the landside toe. This area is an extension of a seepage berm placed on an emergency work order in February 2017. Site ID No: 581 Site Designation: LMA-487 Repair Type: Seepage Rating: Area of Concern Field Date: 8/14/2017 Notes:

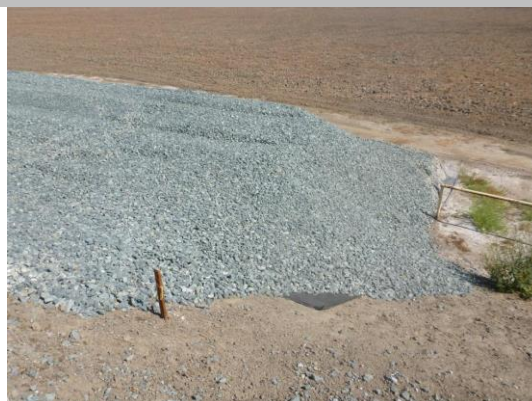
Photo 2 of 3 : FA\_2019\_RD2064\_313\_24\_20190830\_00007.jpg

LM Start	3.92	Rating **	A/W	Issue No.	24 (cont)	
LM End	4.03	Issue Type +	Ob	Location *		
Category	Supplemental			GPS Latitude/Longitude		
				Start	End	
Item	2017 Storm Damage			37.673190 °	37.672180 °	
				-121.258140 °	-121.256490 °	
DWR ID	LMA-487					
Comment Code						
Inspector Comment						
Levee Evaluation Comments						
Description:The damaged area is due to extensive seepage occurring from high river flows, especially when the water level is above 25.0' at the Vernalis Gauge. The damage is from long-term saturated soil within the levee structure beyond the landside toe. This area is an extension of a seepage berm placed on an emergency work order in February 2017.						
Site ID No:581						
Site Designation:LMA-487						
Repair Type: Seepage						
Rating:Area of Concern						
Field Date:8/14/2017						
Notes:

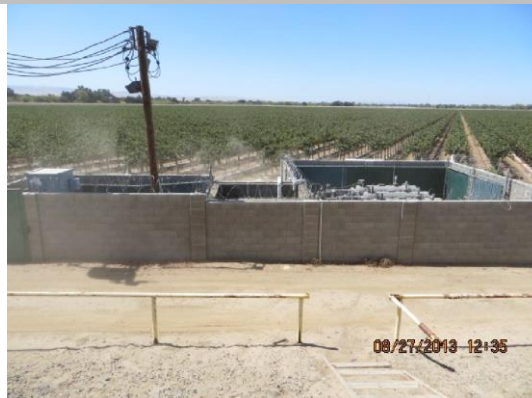
Photo 1 of 2 : UCIP\_FA\_2019\_19063\_31861.jpg

Concrete distribution box remains in center of structure on LS toe.

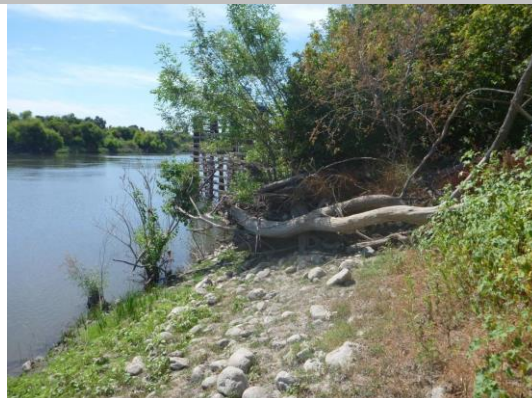
Photo 1 of 3 : FA\_2019\_RD2064\_313\_26\_20190830\_00009.jpg

LM Start	4.82	Rating **	A/W	Issue No.	26
LM End	4.85	Issue Type +	Ma	Location *	
Category	Supplemental			GPS Latitude/Longitude	
				Start	End
Item	2017 Storm Damage			37.671730 °	37.672140 °
				-121.246820 °	-121.246800 °
DWR ID	LMA-489				
Comment Code					
Inspector Comment					
Levee Evaluation Comments					
Description:Erosion from high water flows caused erosion scarps from 12" to 24" in height. The area of damage is approximately 600 feet in length.					
Site ID No:583					
Site Designation:LMA-489					
Repair Type: Erosion					
Rating:Area of Concern					
Field Date:8/14/2017					
Notes: Minor toe erosion

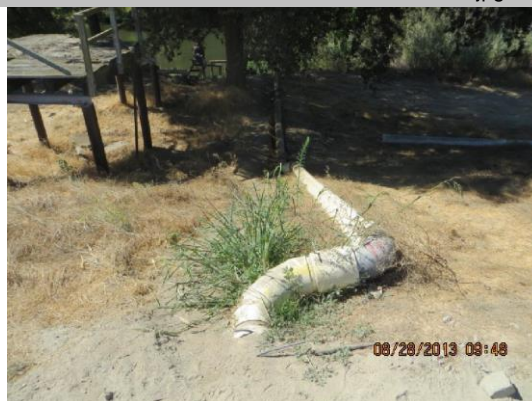
Photo 2 of 3 : UCIP\_FA\_2019\_44653\_37714.jpg

Pipe visible on WS shoulder/slope.

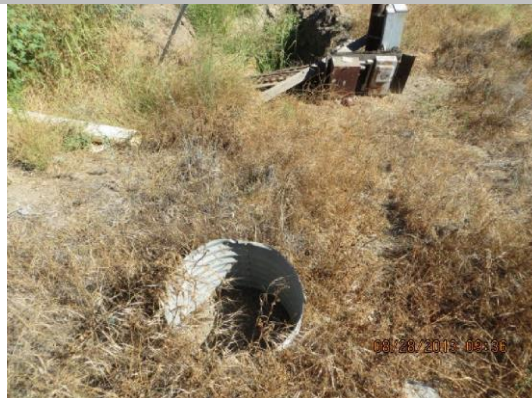
Photo 1 of 3 : UCIP\_FA\_2019\_51385\_31892.jpg

Siphon breaker in 24-inch CMP riser on LS shoulder.

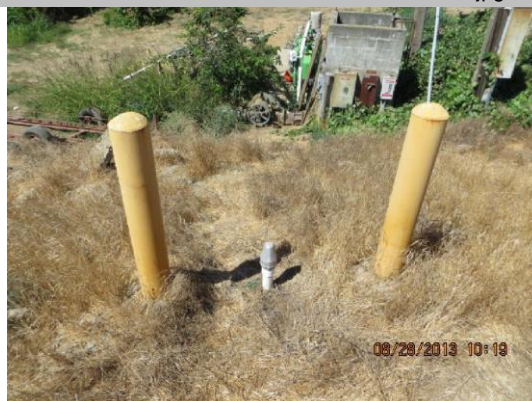
Photo 2 of 3 : UCIP\_FA\_2019\_22095\_37721.jpg

Vent on LS shoulder.

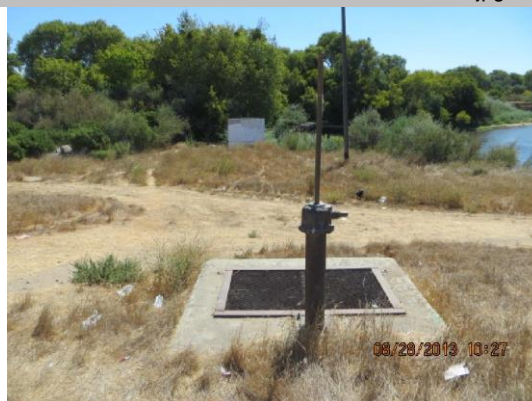
Photo 1 of 3 : UCIP\_FA\_2019\_19086\_31954.jpg

Gate valve on WS shoulder. Pump next to concrete riser in background.

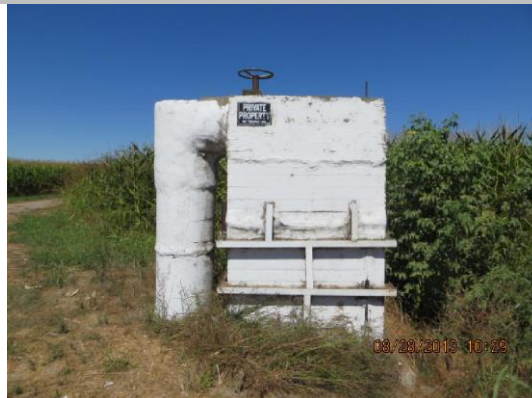
Photo 3 of 3 : UCIP\_FA\_2019\_19086\_31952.jpg

Comment Code						
Inspector Comment						
DS_ID:20540 FS_ID:19086 EP_NO: N/A Repair Type: Non-Urgent Crossing Status: Found UCIP Comments: Leak next to roadway may indicate pipe has reached life capacity-good candidate for video inspection. FIELD_STRUCT_DESC: 30-inch by 30-inch reinforced concrete box irrigation culvert through the levee, 14.5 feet below the crown. Pipe reduced to 24-inch through the berm to pump house. Slide gate in a 6-foot by 7-foot concrete riser on the waterside (WS) slope. Slant pump mounted on the berm next to a 5-foot by 9-foot concrete riser. 1.5-inch electrical conduit at the same location. [Additional Reference(s): DWR Levee Log, 2005. USACE San Joaquin O&M Manual 3, December 1968, (HLM 2.51)]. FS Date: 8/28/2013

Concrete riser in field north of levee likely outlet for cox culvert.

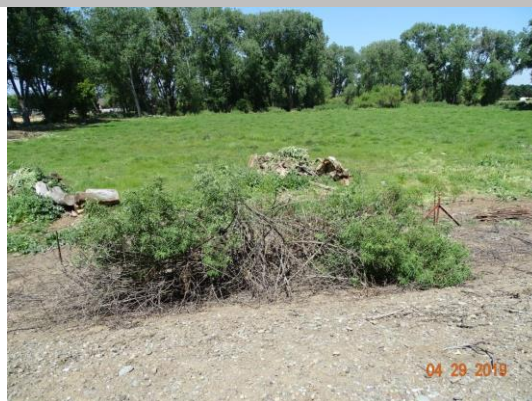
Photo 1 of 1 : FA\_2019\_RD2064\_314\_38\_20190830\_00010.jpg

LM Start	2.84	Rating **	M	Issue No.	38
LM End	2.84	Issue Type +	En	Location *	LS
Category	Earthen Levee			GPS Latitude/Longitude	
				Start	End
Item	Encroachments			37.685977 °	37.685977 °
				-121.219518 °	-121.219518 °
DWR ID	DWR_RD2064_02_s_2019_38				
Comment Code					
PR : Prunings					
Inspector Comment					
There is a pruning pile on the landside shoulder.

View of pruning pile on landside shoulder obstructing visibility. (Spring 2019)

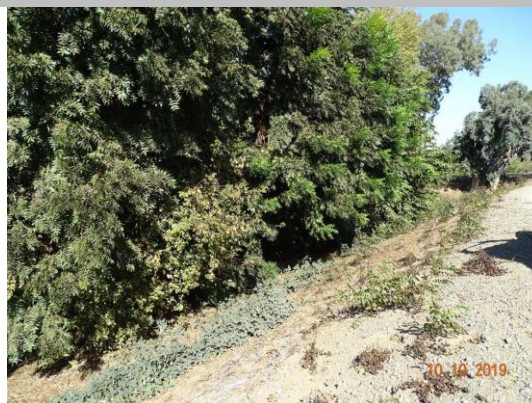
Photo 1 of 1 : FA\_2019\_RD2064\_314\_42\_20191111\_00056.jpg

LM Start	4.09	Rating **	U	Issue No.	42
LM End	4.12	Issue Type +	Ma	Location *	LS
Category	Earthen Levee			GPS Latitude/Longitude	
				Start	End
Item	Trim / Thin Trees			37.693944 °	37.694359 °
				-121.207286 °	-121.207224 °
DWR ID	DWR_RD2064_02_f_2019_42				
Comment Code					
T3 : Trim and thin trees to allow visibility of the ground and room to flood fight.					
Inspector Comment

View of trees on landside slope. Fall 2019

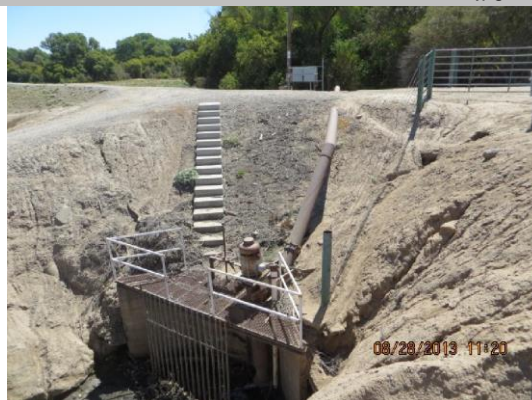
Photo 1 of 2 : UCIP\_FA\_2019\_22107\_37736.jpg

LM Start	4.24	Rating **	M	Issue No.	49
LM End	4.24	Issue Type +	En	Location *	
Category	Supplemental			GPS Latitude/Longitude	
				Start	End
Item	DRAFT DWR UCIP Field Study			37.695745 °	37.695745 °
				-121.205865 °	-121.205865 °
DWR ID	24064				
Comment Code					
Inspector Comment					
DS_ID:24064 FS_ID:22107 EP_NO: N/A Repair Type: Non-Urgent Crossing Status: Found UCIP Comments: Pipe does not have adequate cover at crown. FIELD_STRUCT_DESC: 12-inch steel discharge pipe through the levee, 0.5 feet below the crown. Pump on concrete headwall at the landside (LS) toe. Pipe discharges into a 6-foot by 7-foot concrete box on the waterside (WS) shoulder. FS Date: 8/28/2013

Pump for pipe on concrete headwall at LS toe.

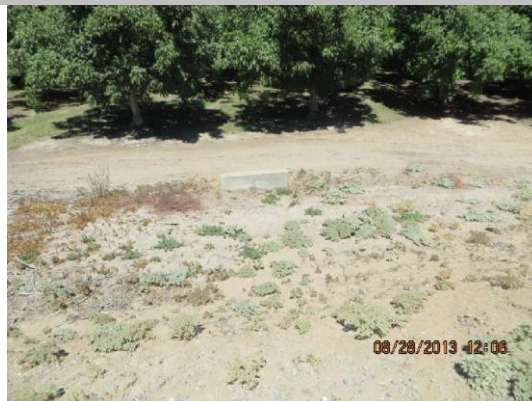
Photo 1 of 3 : UCIP\_FA\_2019\_19117\_32069.jpg

LM Start	4.41	Rating **	A/W	Issue No.	50	
LM End	4.41	Issue Type +	Ma	Location *		
Category	Supplemental			GPS Latitude/Longitude		
				Start		End
Item	DRAFT DWR UCIP LMA Responsibility			37.696386 °		37.696386 °
				-121.202963 °		-121.202963 °
DWR ID	20549					
Comment Code						
Inspector Comment						
DS_ID:20549 FS_ID:19117 EP_NO: N/A Repair Type: No Action Needed Crossing Status: Found UCIP Comments: FIELD_STRUCT_DESC: 30-inch drainage pipe of an unknown material through the levee, 10.5 feet below the crown. Concrete U-shaped headwalls on both ends. Flap gate on the waterside (WS) end. Two corrugated metal cutoff walls. [Additional Reference(s): DWR Levee Log, 2005. USACE San Joaquin O&M Manual 3, December 1968, (HLM 4.37)]. FS Date: 8/28/2013

Headwall on LS toe.

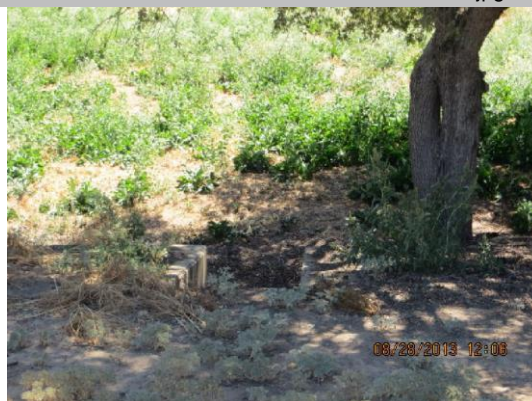
Photo 2 of 3 : UCIP\_FA\_2019\_19117\_32068.jpg

LM Start	4.41	Rating **	A/W	Issue No.	50 (cont)	
LM End	4.41	Issue Type +	Ma	Location *		
Category	Supplemental			GPS Latitude/Longitude		
				Start	End	
Item	DRAFT DWR UCIP LMA Responsibility			37.696386 °	37.696386 °	
				-121.202963 °	-121.202963 °	
DWR ID	20549					
Comment Code						
Inspector Comment						
DS_ID:20549 FS_ID:19117 EP_NO: N/A Repair Type: No Action Needed Crossing Status: Found UCIP Comments: FIELD_STRUCT_DESC: 30-inch drainage pipe of an unknown material through the levee, 10.5 feet below the crown. Concrete U-shaped headwalls on both ends. Flap gate on the waterside (WS) end. Two corrugated metal cutoff walls. [Additional Reference(s): DWR Levee Log, 2005. USACE San Joaquin O&M Manual 3, December 1968, (HLM 4.37)]. FS Date: 8/28/2013

Headwall on WS toe.

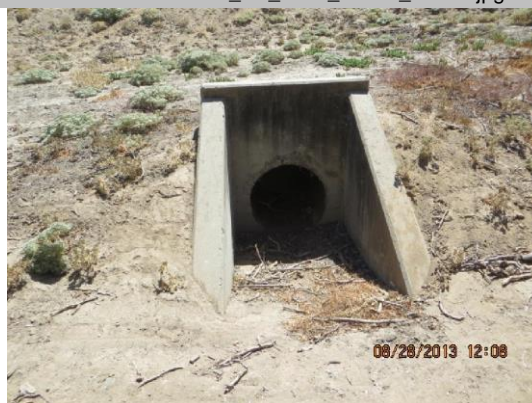
Photo 3 of 3 : UCIP\_FA\_2019\_19117\_32067.jpg

Headwall on LS toe.

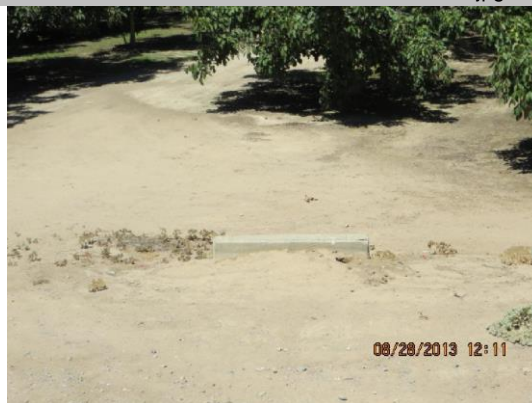
Photo 2 of 3 : UCIP\_FA\_2019\_22793\_38841.jpg

LM Start	4.51	Rating **	A/W	Issue No.	51
LM End	4.51	Issue Type +	Ma	Location *	
Category	Supplemental			GPS Latitude/Longitude	
				Start	End
Item	DRAFT DWR UCIP LMA Responsibility			37.696892 °	37.696892 °
				-121.201228 °	-121.201228 °
DWR ID	20550				
Comment Code					
Inspector Comment					
DS_ID:20550 FS_ID:22793 EP_NO: N/A Repair Type: No Action Needed Crossing Status: Found UCIP Comments: FIELD_STRUCT_DESC: 30-inch corrugated metal drainage pipe through the levee, 8 feet below the crown. Concrete U-shaped headwalls on both ends, and a flap gate on the waterside (WS) end. Grouted spillway on the WS. [Additional Reference(s): DWR Levee Log, 2005. USACE San Joaquin O&M Manual 3, December 1968, (HLM 4.47)]. FS Date: 8/28/2013

Concrete headwall on LS toe.

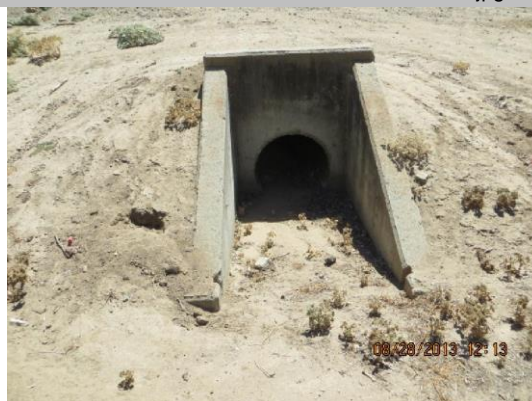
Photo 3 of 3 : UCIP\_FA\_2019\_22793\_38844.jpg

LM Start	4.51	Rating **	A/W	Issue No.	51 (cont)	
LM End	4.51	Issue Type +	Ma	Location *		
Category	Supplemental			GPS Latitude/Longitude		
				Start		End
Item	DRAFT DWR UCIP LMA Responsibility			37.696892 °		37.696892 °
				-121.201228 °		-121.201228 °
DWR ID	20550					
Comment Code						
Inspector Comment						
DS_ID:20550						
FS_ID:22793						
EP_NO: N/A						
Repair Type: No Action Needed						
Crossing Status: Found						
UCIP Comments:						
FIELD_STRUCT_DESC: 30-inch corrugated metal drainage pipe through the levee, 8 feet below the crown. Concrete U-shaped headwalls on both ends, and a flap gate on the waterside (WS) end. Grouted spillway on the WS. [Additional Reference(s): DWR Levee Log, 2005. USACE San Joaquin O&M Manual 3, December 1968, (HLM 4.47)].						
FS Date: 8/28/2013

Concrete headwall on LS toe.

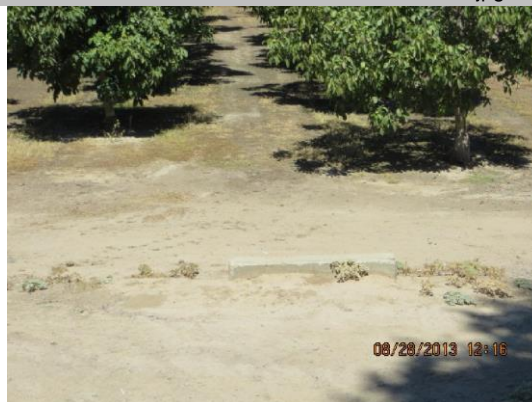
Photo 1 of 3 : UCIP\_FA\_2019\_19120\_32079.jpg

LM Start	4.64	Rating **	A/W	Issue No.	52
LM End	4.64	Issue Type +	Ma	Location *	
Category	Supplemental			GPS Latitude/Longitude	
				Start	End
Item	DRAFT DWR UCIP LMA Responsibility			37.697101 °	37.697101 °
				-121.199048 °	-121.199048 °
DWR ID	20551				
Comment Code					
Inspector Comment					
DS_ID:20551					
FS_ID:19120					
EP_NO: N/A					
Repair Type: No Action Needed					
Crossing Status: Found					
UCIP Comments:					
FIELD_STRUCT_DESC: 30-inch corrugated metal drainage pipe through the levee, 10 feet below the crown. Concrete U-shaped headwalls on both ends. Flap gate on the waterside (WS) end. Two corrugated metal cutoff walls. Grouted spillway on the WS. Spillway damaged due to uprooted tree. [Additional Reference(s): DWR Levee Log, 2005. USACE San Joaquin O&M Manual 3, December 1968, (HLM 4.59)].					
FS Date: 8/28/2013

Concrete headwall on LS toe.

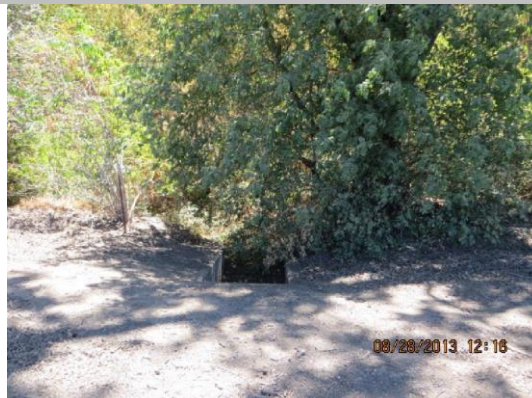
Photo 2 of 3 : UCIP\_FA\_2019\_19120\_32078.jpg

LM Start	4.64	Rating **	A/W	Issue No.	52 (cont)	
LM End	4.64	Issue Type +	Ma	Location *		
Category	Supplemental			GPS Latitude/Longitude		
				Start		End
Item	DRAFT DWR UCIP LMA Responsibility			37.697101 °		37.697101 °
				-121.199048 °		-121.199048 °
DWR ID	20551					
Comment Code						
Inspector Comment						
DS_ID:20551 FS_ID:19120 EP_NO: N/A Repair Type: No Action Needed Crossing Status: Found UCIP Comments: FIELD_STRUCT_DESC: 30-inch corrugated metal drainage pipe through the levee, 10 feet below the crown. Concrete U-shaped headwalls on both ends. Flap gate on the waterside (WS) end. Two corrugated metal cutoff walls. Grouted spillway on the WS. Spillway damaged due to uprooted tree. [Additional Reference(s): DWR Levee Log, 2005. USACE San Joaquin O&M Manual 3, December 1968, (HLM 4.59)]. FS Date: 8/28/2013

Concrete headwall on WS toe.

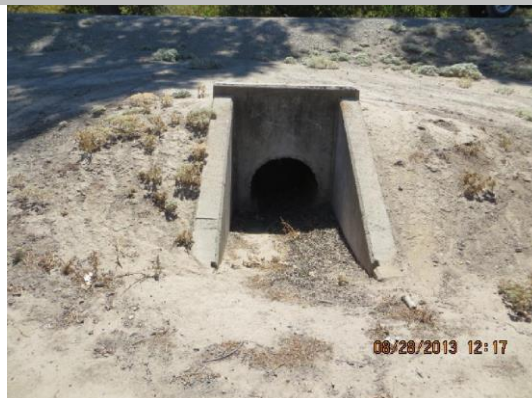
Photo 3 of 3 : UCIP\_FA\_2019\_19120\_32077.jpg

Concrete headwall on LS toe.

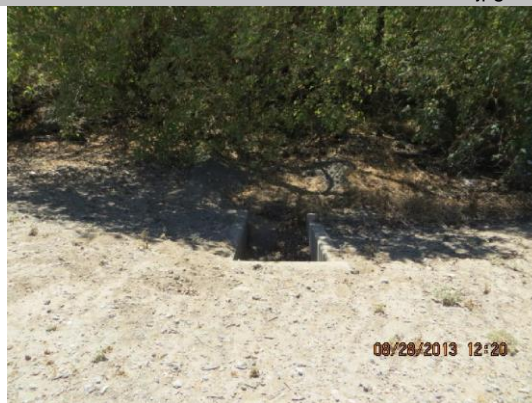
Photo 2 of 3 : UCIP\_FA\_2019\_19122\_32082.jpg

LM Start	4.78	Rating **	A/W	Issue No.	53
LM End	4.78	Issue Type +	Ma	Location *	
Category	Supplemental			GPS Latitude/Longitude	
				Start	End
Item	DRAFT DWR UCIP LMA Responsibility			37.696888 °	37.696888 °
				-121.196511 °	-121.196511 °
DWR ID	20552				
Comment Code					
Inspector Comment					
DS_ID:20552					
FS_ID:19122					
EP_NO: N/A					
Repair Type: No Action Needed					
Crossing Status: Found					
UCIP Comments:					
FIELD_STRUCT_DESC: 30-inch corrugated metal drainage pipe through the levee, 8.5 feet below the crown. Concrete U-shaped headwalls on both ends. Flap gate on the waterside (WS) end. Two corrugated metal cutoff walls. Grouted spillway on the WS. [Additional Reference(s): DWR Levee Log, 2005. USACE San Joaquin O&M Manual 3, December 1968, (HLM 4.73)].					
FS Date: 8/28/2013

Concrete headwall on WS toe.

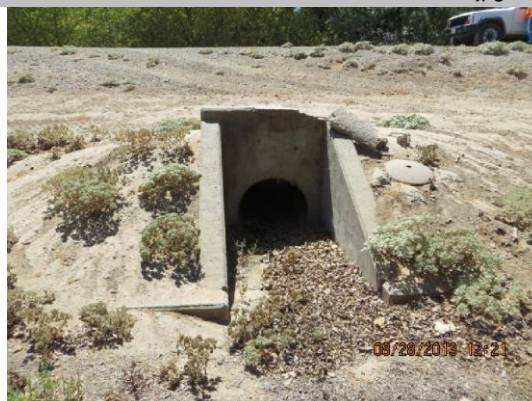
Photo 3 of 3 : UCIP\_FA\_2019\_19122\_32081.jpg

LM Start	4.78	Rating **	A/W	Issue No.	53 (cont)
LM End	4.78	Issue Type +	Ma	Location *	
Category	Supplemental			GPS Latitude/Longitude	
				Start	End
Item	DRAFT DWR UCIP LMA Responsibility			37.696888 °	37.696888 °
				-121.196511 °	-121.196511 °
DWR ID	20552				
Comment Code					
Inspector Comment					
DS_ID:20552 FS_ID:19122 EP_NO: N/A Repair Type: No Action Needed Crossing Status: Found UCIP Comments: FIELD_STRUCT_DESC: 30-inch corrugated metal drainage pipe through the levee, 8.5 feet below the crown. Concrete U-shaped headwalls on both ends. Flap gate on the waterside (WS) end. Two corrugated metal cutoff walls. Grouted spillway on the WS. [Additional Reference(s): DWR Levee Log, 2005. USACE San Joaquin O&M Manual 3, December 1968, (HLM 4.73)]. FS Date: 8/28/2013

Concrete headwall on LS toe.

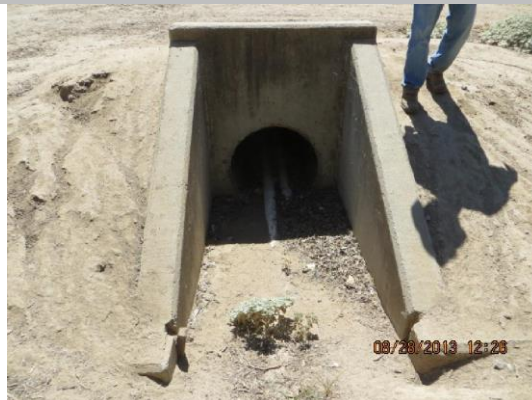
Photo 1 of 3 : UCIP\_FA\_2019\_22108\_37739.jpg

LM Start	4.92	Rating **	M	Issue No.	54
LM End	4.92	Issue Type +	En	Location *	
Category	Supplemental			GPS Latitude/Longitude	
				Start	End
Item	DRAFT DWR UCIP Field Study			37.696146 °	37.696146 °
				-121.194093 °	-121.194093 °
DWR ID	24065				
Comment Code					
Inspector Comment					
DS_ID:24065 FS_ID:22108 EP_NO: N/A Repair Type: Non-Urgent Crossing Status: Found UCIP Comments: No permit identified for this discharge pipe. FIELD_STRUCT_DESC: 1 of 2: 4-inch polyvinyl chloride (PVC) discharge pipe through the 30-inch drainage pipe, 11 feet below the crown. No permit. FS Date: 8/28/2013

PVC pipe at right inside stormdrain on LS toe.

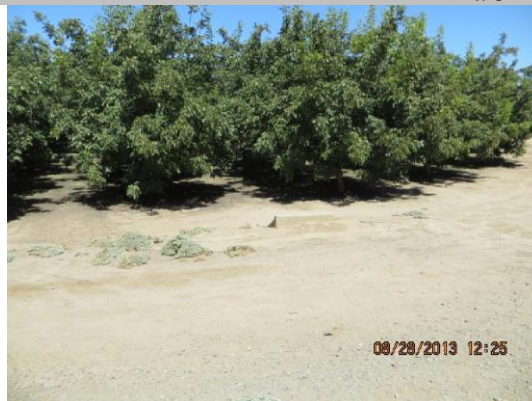
Photo 1 of 3 : UCIP\_FA\_2019\_19143\_32122.jpg

LM Start	4.92	Rating **	A/W	Issue No.	56
LM End	4.92	Issue Type +	Ma	Location *	
Category	Supplemental			GPS Latitude/Longitude	
				Start	End
Item	DRAFT DWR UCIP LMA Responsibility			37.696146 °	37.696146 °
				-121.194093 °	-121.194093 °
DWR ID	20553				
Comment Code					
Inspector Comment					
DS_ID:20553					
FS_ID:19143					
EP_NO: N/A					
Repair Type: No Action Needed					
Crossing Status: Found					
UCIP Comments:					
FIELD_STRUCT_DESC: 30-inch corrugated metal drainage pipe through the levee, 8 feet below the crown. Concrete U-shaped headwalls on both ends. Flap gate on the waterside (WS) end. Two corrugated metal cutoff walls. Grouted spillway on the WS. [Additional Reference(s): DWR Levee Log, 2005. USACE San Joaquin O&M Manual 3, December 1968, (HLM 4.88)].					
FS Date: 8/28/2013

Concrete headwall on LS toe.

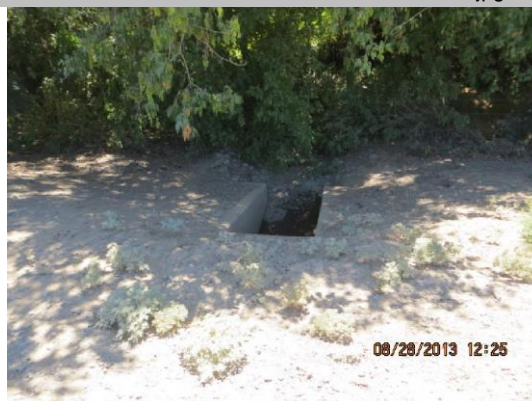
Photo 2 of 3 : UCIP\_FA\_2019\_19143\_32121.jpg

LM Start	4.92	Rating **	A/W	Issue No.	56 (cont)	
LM End	4.92	Issue Type +	Ma	Location *		
Category	Supplemental			GPS Latitude/Longitude		
				Start		End
Item	DRAFT DWR UCIP LMA Responsibility			37.696146 °		37.696146 °
				-121.194093 °		-121.194093 °
DWR ID	20553					
Comment Code						
Inspector Comment						
DS_ID:20553 FS_ID:19143 EP_NO: N/A Repair Type: No Action Needed Crossing Status: Found UCIP Comments: FIELD_STRUCT_DESC: 30-inch corrugated metal drainage pipe through the levee, 8 feet below the crown. Concrete U-shaped headwalls on both ends. Flap gate on the waterside (WS) end. Two corrugated metal cutoff walls. Grouted spillway on the WS. [Additional Reference(s): DWR Levee Log, 2005. USACE San Joaquin O&M Manual 3, December 1968, (HLM 4.88)]. FS Date: 8/28/2013

Concrete headwall on WS toe.

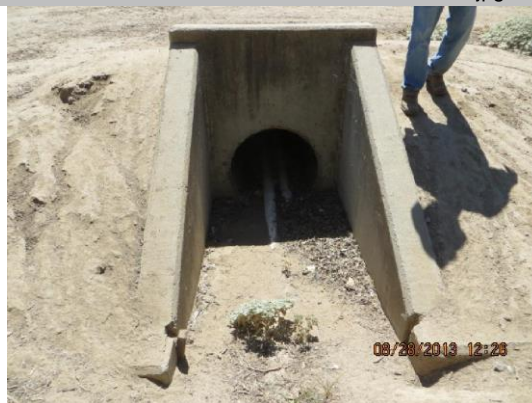
Photo 3 of 3 : UCIP\_FA\_2019\_19143\_32120.jpg

Concrete headwall on LS toe.

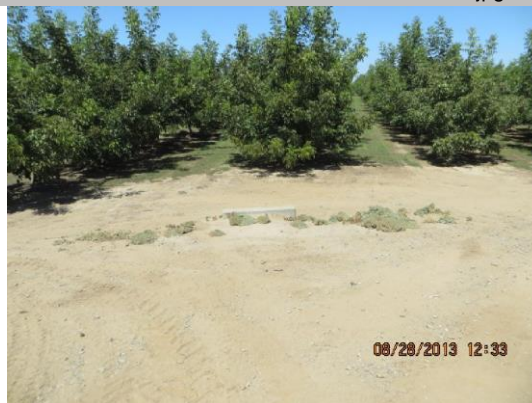
Photo 2 of 3 : UCIP\_FA\_2019\_22794\_38850.jpg

LM Start	5.10	Rating **	A/W	Issue No.	57
LM End	5.10	Issue Type +	Ma	Location *	
Category	Supplemental			GPS Latitude/Longitude	
				Start	End
Item	DRAFT DWR UCIP LMA Responsibility			37.697483 °	37.697483 °
				-121.191332 °	-121.191332 °
DWR ID	20554				
Comment Code					
Inspector Comment					
DS_ID:20554 FS_ID:22794 EP_NO: N/A Repair Type: No Action Needed Crossing Status: Found UCIP Comments: FIELD_STRUCT_DESC: 30-inch corrugated metal drainage pipe through the levee, 8 feet below the crown. Concrete U-shaped headwalls on both ends. Flap gate on the waterside (WS) end. Two corrugated metal cutoff walls. Grouted spillway on the WS. [Additional Reference(s): DWR Levee Log, 2005. USACE San Joaquin O&M Manual 3, December 1968, (HLM 5.05)]. FS Date: 8/28/2013

Concrete headwall on LS toe.

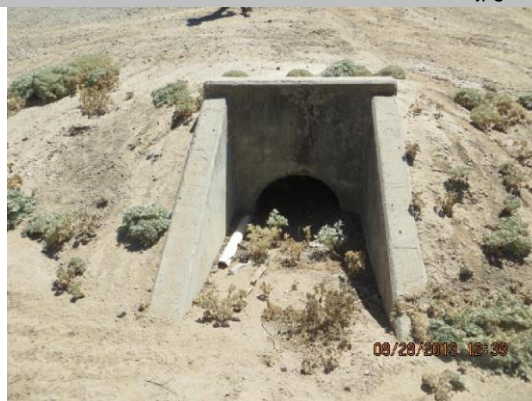
Photo 3 of 3 : UCIP\_FA\_2019\_22794\_38853.jpg

LM Start	5.10	Rating **	A/W	Issue No.	57 (cont)	
LM End	5.10	Issue Type +	Ma	Location *		
Category	Supplemental			GPS Latitude/Longitude		
				Start	End	
Item	DRAFT DWR UCIP LMA Responsibility			37.697483 °	37.697483 °	
				-121.191332 °	-121.191332 °	
DWR ID	20554					
Comment Code						
Inspector Comment						
DS_ID:20554 FS_ID:22794 EP_NO: N/A Repair Type: No Action Needed Crossing Status: Found UCIP Comments: FIELD_STRUCT_DESC: 30-inch corrugated metal drainage pipe through the levee, 8 feet below the crown. Concrete U-shaped headwalls on both ends. Flap gate on the waterside (WS) end. Two corrugated metal cutoff walls. Grouted spillway on the WS. [Additional Reference(s): DWR Levee Log, 2005. USACE San Joaquin O&M Manual 3, December 1968, (HLM 5.05)]. FS Date: 8/28/2013

Concrete headwall on LS toe.

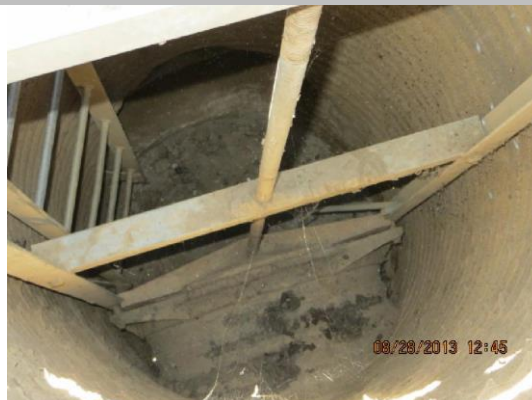
Photo 2 of 2 : UCIP\_FA\_2019\_19145\_32125.jpg

LM Start	5.54	Rating **	M	Issue No.	59	
LM End	5.54	Issue Type +	En	Location *		
Category	Supplemental			GPS Latitude/Longitude		
				Start		End
Item	DRAFT DWR UCIP Field Study			37.699848 °		37.699848 °
				-121.184135 °		-121.184135 °
DWR ID	20555					
Comment Code						
Inspector Comment						
DS_ID:20555 FS_ID:19145 EP_NO: N/A Repair Type: Non-Urgent Crossing Status: Found UCIP Comments: Appears abandoned and if so should be done so appropriately. FIELD_STRUCT_DESC: *ABANDONED* 30-inch corrugated metal irrigation pipe through the levee, 10 feet below the crown. Slide gate in a 36-inch corrugated metal pipe (CMP) riser on the waterside (WS) slope. Two corrugated metal cutoff walls. [Additional Reference(s): DWR Levee Log, 2005. USACE San Joaquin O&M Manual 3, December 1968, (HLM 5.48)]. FS Date: 8/28/2013

Pipe in CMP riser on WS slope.

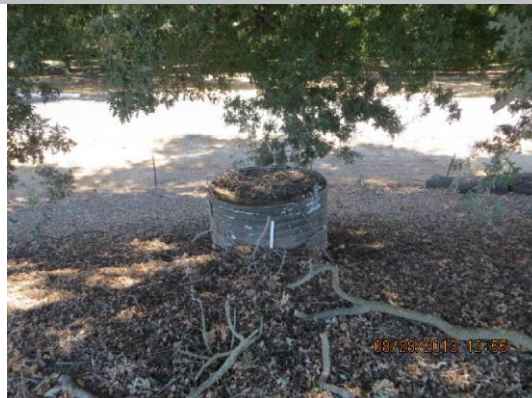
Photo 1 of 1 : UCIP\_FA\_2019\_19146\_32127.jpg

Comment Code					
Inspector Comment					
DS_ID:20556					
FS_ID:19146					
EP_NO: N/A					
Repair Type: Non-Urgent					
Crossing Status: Found					
UCIP Comments: Slide gate missing and CMP riser filled with soil.					
Appears abandoned and should be done so properly.					
FIELD_STRUCT_DESC: 20-inch corrugated metal irrigation pipe					
through the levee, 13 feet below the crown. Slide gate in a corrugated					
metal pipe (CMP) riser on the waterside (WS) slope. Two corrugated					
metal cutoff walls. Underground irrigation system. [Additional					
Reference(s): DWR Levee Log, 2005. USACE San Joaquin O&M					
Manual 3, December 1968, (HLM 5.69)].					
FS Date: 8/28/2013

CMP riser for slide gate filled with soil.
